PERFORMANCE OF BUILT ENVIRONMENT IN THE OCT 1999 ORISSA SUPER CYCLONE

Simon Francis, Prasad V S K Gunturi, Munish Arora
R.M.S.I., A-7, Sector -16, Noida, U.P.
(E-mail: info@rmsi.com, Web: www.rmsi.com)

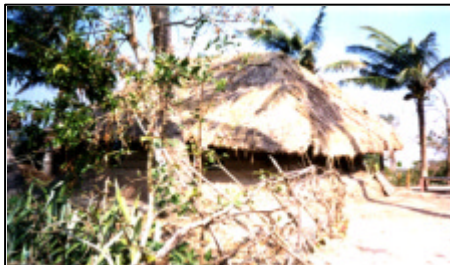
Dwellings in the coastal regions of Orissa are predominantly non-engineered construction though both semi-engineered and engineered also exist. Among the non-engineered, a typical dwelling is a single storied structure with pitched thatch roof on mud walls. The roof cover comprising dried grass and leaves is placed on a bamboo strip frame and the mud walls in most cases are reinforced with bamboo strips.

Fig 2 A typical dwelling in rural Orissa.

Typical damage states of such houses ranged from blowing-off of thatch cover to complete collapse of mud walls either due to surge or due to extreme winds. The typical medium damage state included complete lifting-off of the roof structure along with the bamboo frame, leaving the mud walls still intact. In the surge-affected areas, a few houses withstood the gushing waters and their mud walls were seen to be still intact, though these may have to be demolished due to loss of strength and loss of resistance to water.
